“Help – save me, please!”

Here is the story of its repair back to an operational condition.

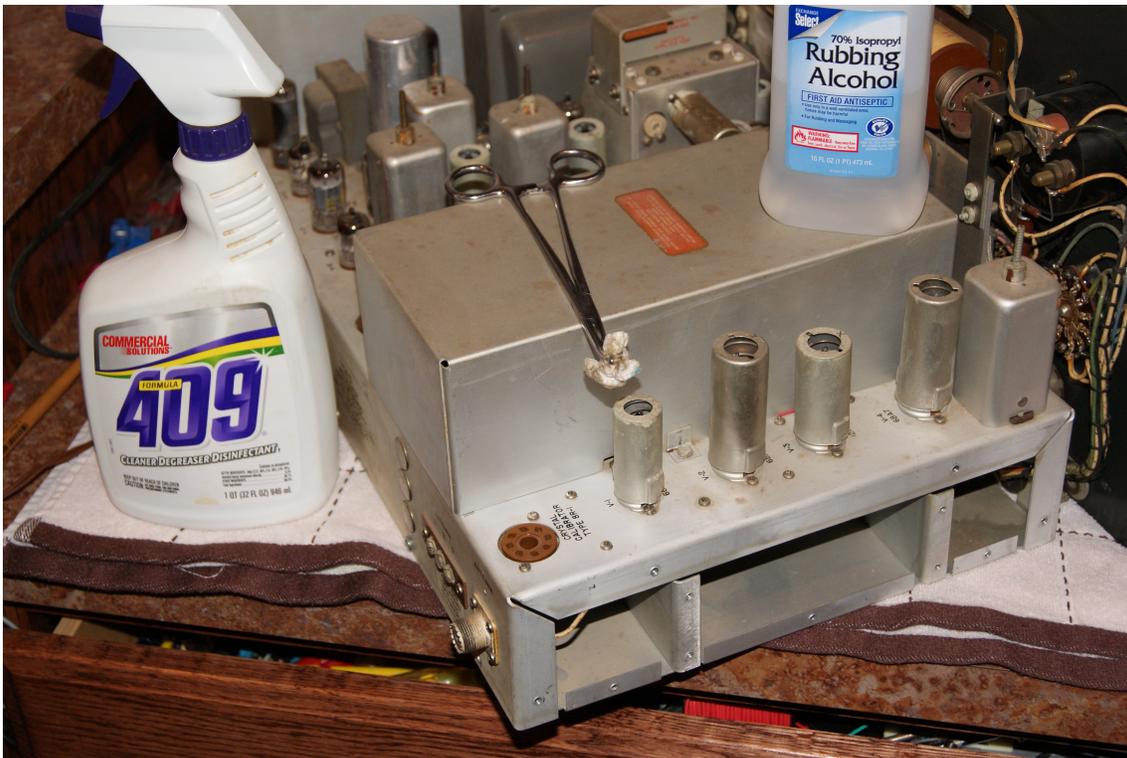
Figure 1. Cleaning Technique

I'll take a small piece of paper towel, wad it up, grab the wad with forceps, hit it with a drop or two of 409 or Simple Green, and rub the dirt and grunge away while carefully paying attention to avoid destroying any chassis markings or decals. Once clean I'll replace the paper towel wad with one that has a dab of rubbing alcohol to remove the cleaning residue. Here you can see an area I've cleaned just around the octal calibrator socket to show how effective this is.

Cleaning: I usually do some cursory cleaning along the way as I repair a radio. That way I can stop troubleshooting for a while when presented with a thorny issue; do some cleaning; and let my brain chew on the problem. Here is a picture of how I usually clean the top of a chassis.

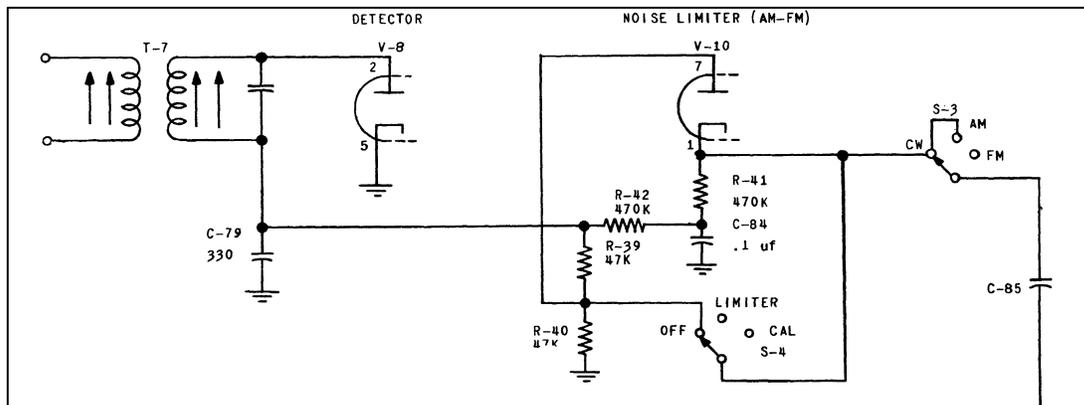
Figure 2. AM Detection and Noise Limiter

AM Detection: So what was unique in AM Mode that would cause it to malfunction? I pulled out the circuit diagram and identified that separate limiting is used for CW (V16) and AM/FM (V10). As soon as I grabbed V10 and started to reseal it, some static came through the speaker. After a couple of additional jiggles of V10 the AM/FM noise limiter began conducting and I heard a nice normal background noise level in the speaker. See figure 2.

At this point all tubes were removed, tested, marginal ones replaced, pins cleaned and reinstalled.

Tube Replacement: I replaced marginal tubes V9 (12AX7); V8 and V10 (6AL5s); and V18 and V5 (6BA6s). The tubes I purchased were NOS and cost me \$32.00. So far, with the capacitors, I've invested \$66.00 in repair parts.

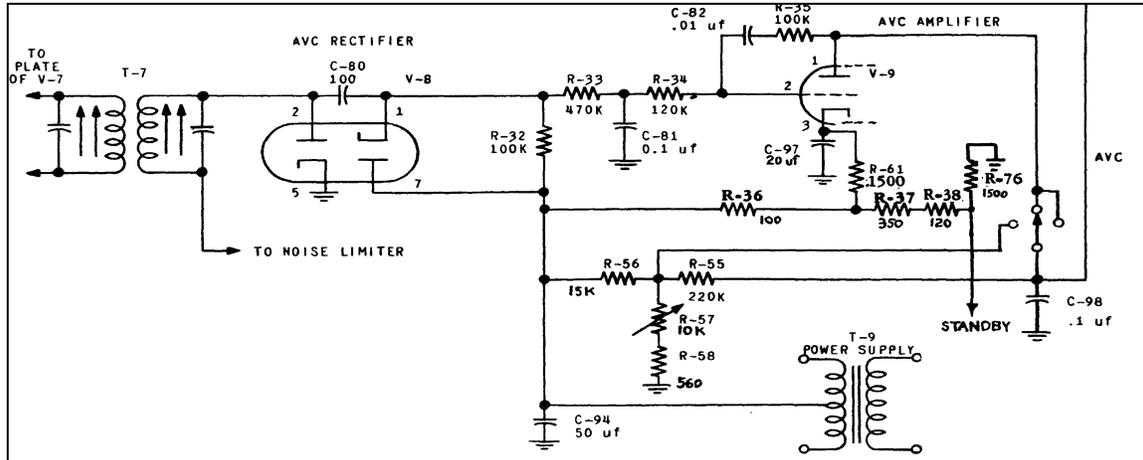
Figure 3. AVC and RF Gain Circuit

In CW mode, AVC is disabled and the gain of the RF and IF stages is determined by the voltage at the junction of R-56 and R-57 (RF Gain Control). Note that the left side of R-56 has a -50 Vdc bias applied. Thus the AVC line should read between -20 Vdc (RF cutoff) and perhaps -1.8 Vdc (at max RF Gain – the manual says it should be -1.7 Vdc) when the receiver is in CW mode and the AVC voltage is measured at the extreme ends of the RF Gain's position. The actual readings were -17.5 and -2.1 Vdc, respectfully.

Normally the set point for no signal AVC is that for maximum RF gain (when AVC is disabled, i.e., in CW mode) and that was the case for this radio (about -2.1 Vdc). The AVC would swing to perhaps -5 Vdc on strong AM signals, so I surmised that the AVC detector (2nd half of V8) and AVC amplifier (1st half of V9) was working, but the set point was off.

Incorrect AVC set point was the result of R58 (see figure 4.) shifting its value to 760 Ohms instead of 560. When it was replaced the AVC set point returned to -1.7 Vdc in accordance with the manual. This ensures maximum gain in weak signal conditions.

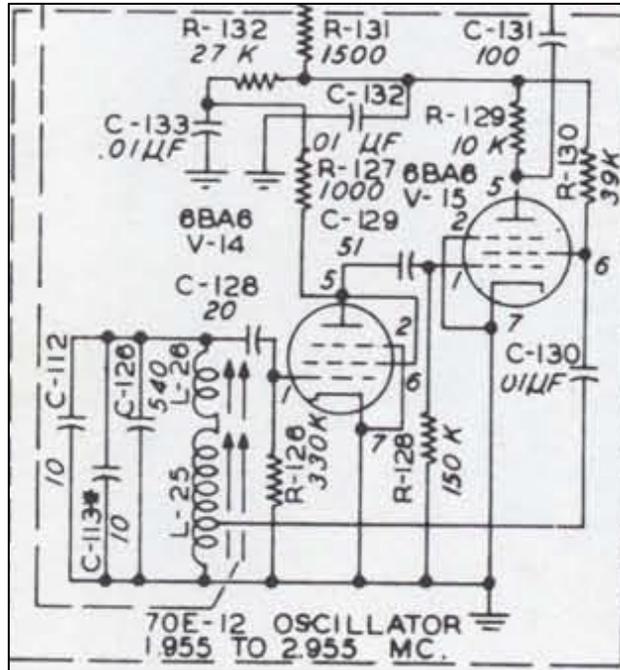
Figure 4. 70E-12 PTO Circuit

PTO Tracking Spread: I discovered the PTO tracking issue while reseating all of the tubes, checking voltages and playing with the radio. Its not excessive and I'm hoping I can recover it by adjusting L26 (see figure 4. below) that is in the PTO. If not, there is an excellent article here on rebuilding the PTO from the now, I'm sorry to say, defunct magazine Ham Radio.

The 70E-12 PTO should tune between 1.955-2.955 MHz or exactly 1 MHz total with exactly 10 turns of the shaft. In my case it took 10.100 turns of the shaft to change the frequency 1 MHz or an absolute error of 10 kHz. That is not acceptable as the fiduciary only allows for an adjustment of +/- 4 kHz.

While I was checking the PTO tracking I also checked the PTO's stability. From a cold start to 20 minutes later it drifted down in frequency ~ 80 Hz and then stabilized into a cyclic drift of about +/- 2 Hz per minute, which seems more than acceptable for a radio built more than 60 years ago.

In my case the powdered iron slug did not have sufficient adjustment to get 10 exact turns of the PTO to coincide with exactly 1.000 MHz of frequency change so I removed one turn from L26 at the end where it attaches to L25.

Since I had cut the galled lock off L26's tuning slug, I put a couple of drops of clear nail polish on the slug's adjustment screw to lock it in place and let it set for 24 hours with the hex nut so as to sufficiently dry.

PTO Tracking Results: I was able to achieve +/- 2 kHz agreement with the dial over the entire range of the PTO which is well within the fiduciary's range of +/- 4 kHz.

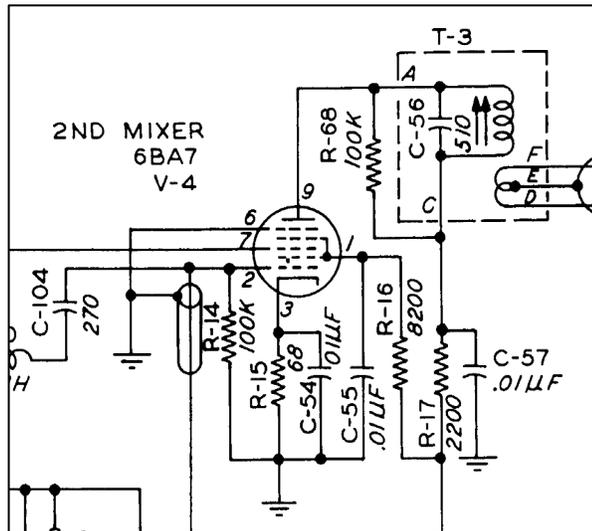
Figure 5. Mystery Components

The mystery components are T3 and C57 in the diagram below (Figure 5.).

The first mystery component is T3, the mixer output transformer. It has a Barker and Williamson identification decal and does not appear to have any Collins part numbers stamped into its side. However, it appears to be an exact fit to the chassis and has the A, C, F, E, D pins clearly stamped in its phenolic base. Perhaps Collins used B&W as one of its suppliers in those days. The soldering on the pins looks original.

The other is C57. Per the parts breakdown in the manual this is supposed to be a ceramic capacitor, yet it is a paper capacitor. It eludes me as to why a paper capacitor was used here and I replaced it with a good quality ceramic capacitor. Strangely, the soldering on the capacitor looks original so I suspect it was installed at the factory.

Also, there was no 100K resistor (R68) across terminals A-C of the mixer's primary transformer. This resistor would serve to lower the Q of the primary so perhaps if Collins went out to B&W to supply

T3 they had them include the resistor inside the can. I'm not going to risk T3 by removing it just to satisfy my curiosity and I didn't add R68 back into the circuit.

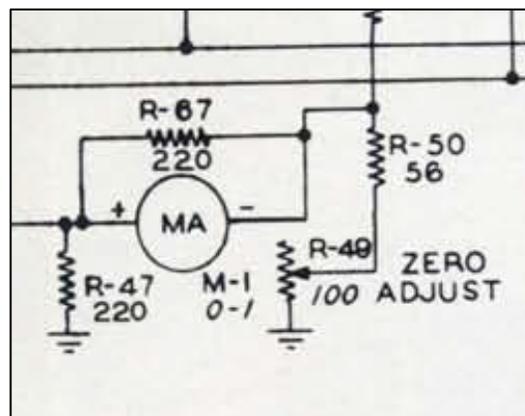
Figure 6. S-Meter Circuit

The S-Meter still wouldn't quite adjust to zero even after getting the AVC threshold established where it should be. I changed R50 (see figure 6) to 75 Ohms and was able to zero the S-Meter. However, the meter was still too sensitive. A 100 uV signal provided an S-Meter reading of between 15-20 dB over S-9, instead of the nominal S-9 signal. I experimented with different values of shunt resistors and selected one that was about 100 Ohms to get a value of S-9 with an RF input signal of 50 uV, which is the industry standard for today's radios.

Note: I could have probably resolved the S-Meter zeroing and sensitivity by going back into the control, cathode, and screen grid circuits of V5, V6, and V7 and change resistors that had aged a bit there, but because I already had a good MDS (see below) I decided this was the easiest path.

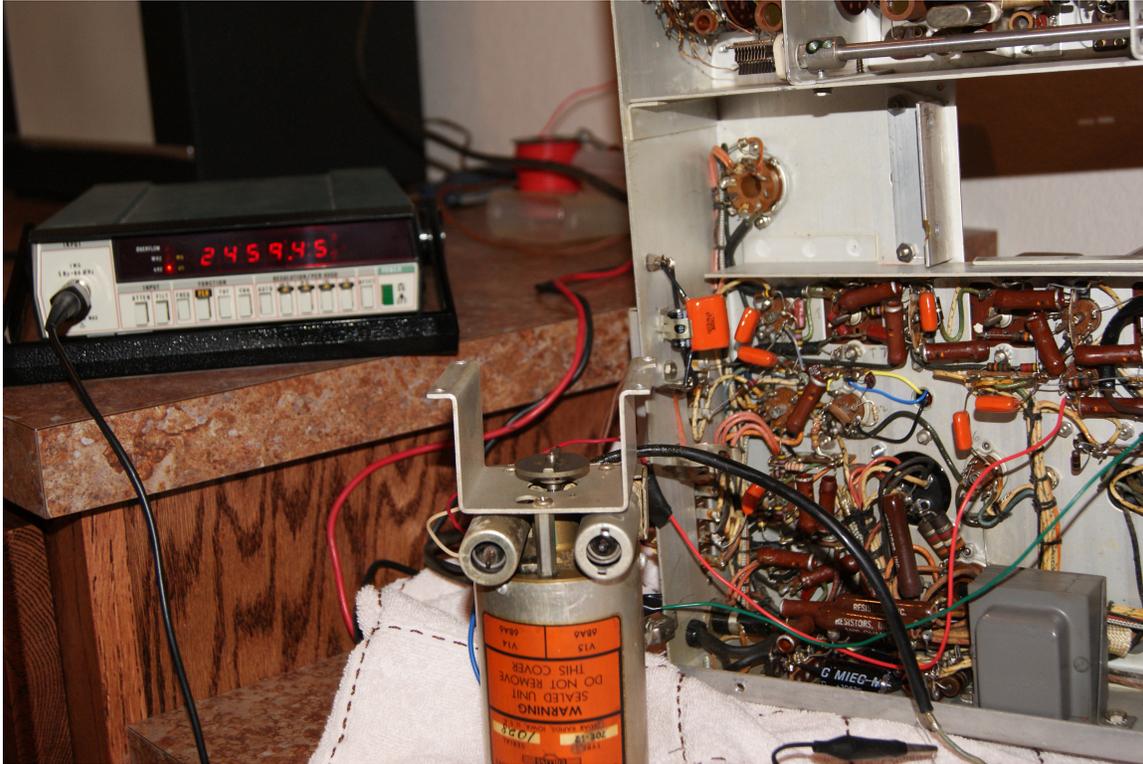
Figure 7. PTO Removed

Once you have it out you can solder some longer temporary leads to the red, green, and white wires and tack them back where they came from. Attach a frequency counter to the coax, I'd suggest using a 10X probe, turn on the receiver, and measure the frequency. It should be close to 2.455 MHz.

See figure 7. *Note, during this part I reattached the front panel back to the chassis to prevent any inadvertent contact with the front panel switches and the chassis.*

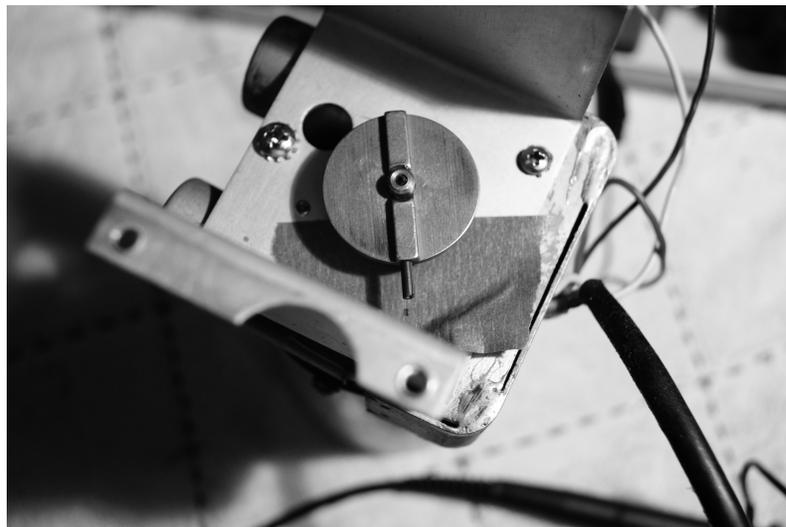
Figure 8. Turn Index

In the Internet article referenced above they made an elaborate jig to hold the PTO and measure the dial revolutions. I found that was unnecessary. A small piece of masking tape was marked at one end of the desired frequency range (either 1.955 or 2.955 MHz) with a small dot under the force fit pin that holds the brass coupler spring. See figure 8.

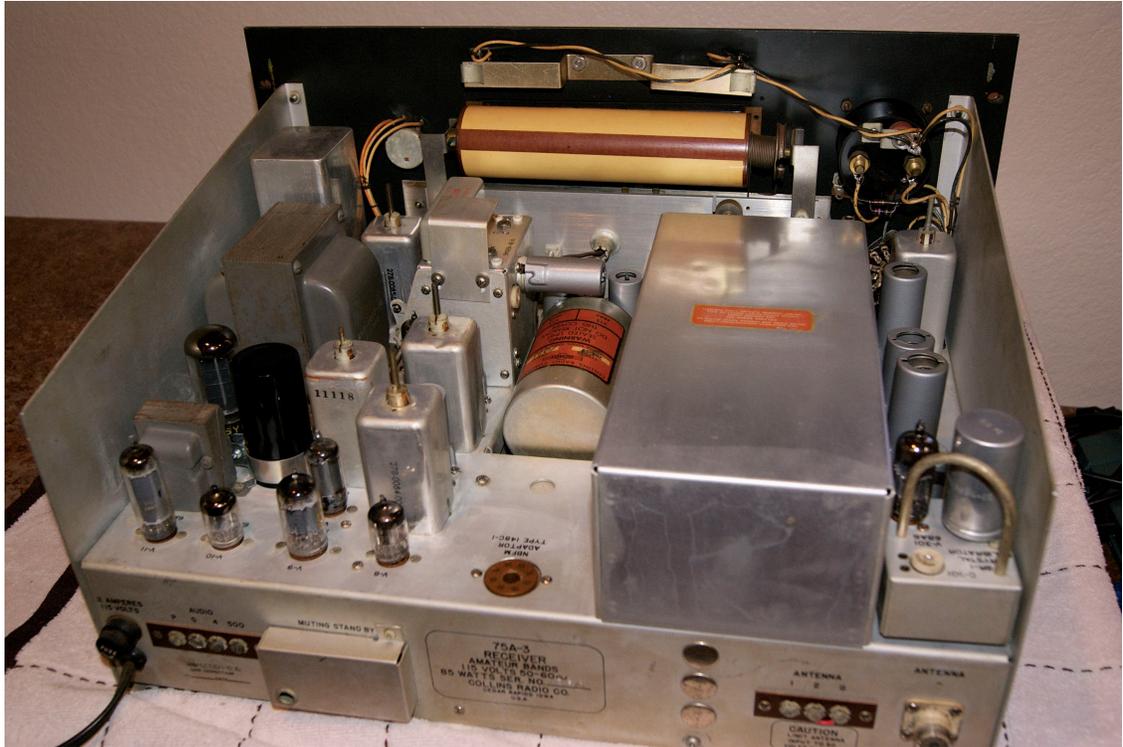
Figure 9. Chassis View

Figure 9 shows a picture from the rear just before it was installed in the newly sprayed cabinet. You can see the black Richey electrolytic and its clamp that was used to replace C95 A/B.

Cosmetics: The rest of the chassis was cleaned; knobs were removed, cleaned and polished with plastic polish; and the tube sockets were spray-painted with hammer tone aluminum paint.

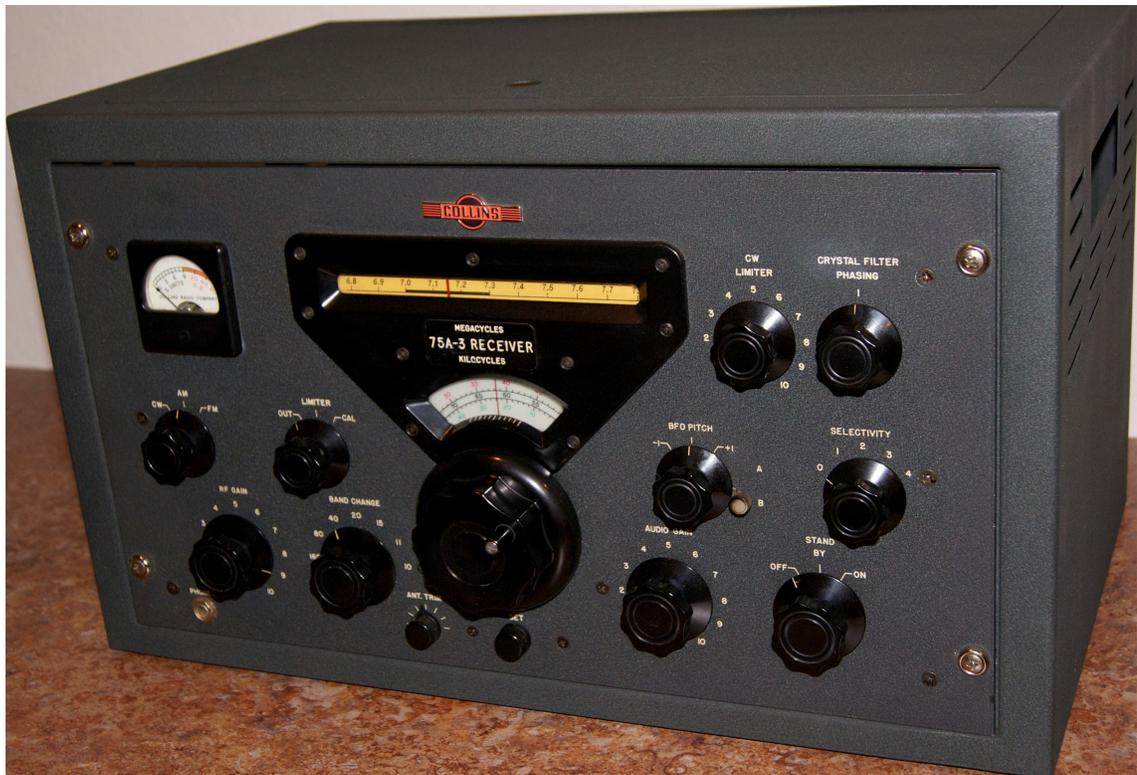
Figure 10. Completed 75A-3

Before I sprayed it with the Collins paint, I touched up the deep scratches with some primer and then gave the entire cabinet a light overspray with Rust-Oleum stone texture spray paint in black. That restored the wrinkle texture nicely. Figure 10 shows the final results.

The cabinet was in good condition, but the paint was dirty and discolored. The panel was nearly pristine without the paint discoloration and dirtiness that the cabinet had. After trying to clean the cabinet, I decided to purchase some spray touchup paint from Surplus Sales in Nebraska (<http://www.surplussales.com>). They have paint that matches the St. James Gray (number 270). Not cheap, at \$24 including shipping, but it allowed me to restore the cabinet back to a color that matched the panel.
