Fine Details on IAP

- NA, PTs, NoPTs, TAAs, and Other Stuff
- Or, Find and Understand The Waldos On Your IAPs

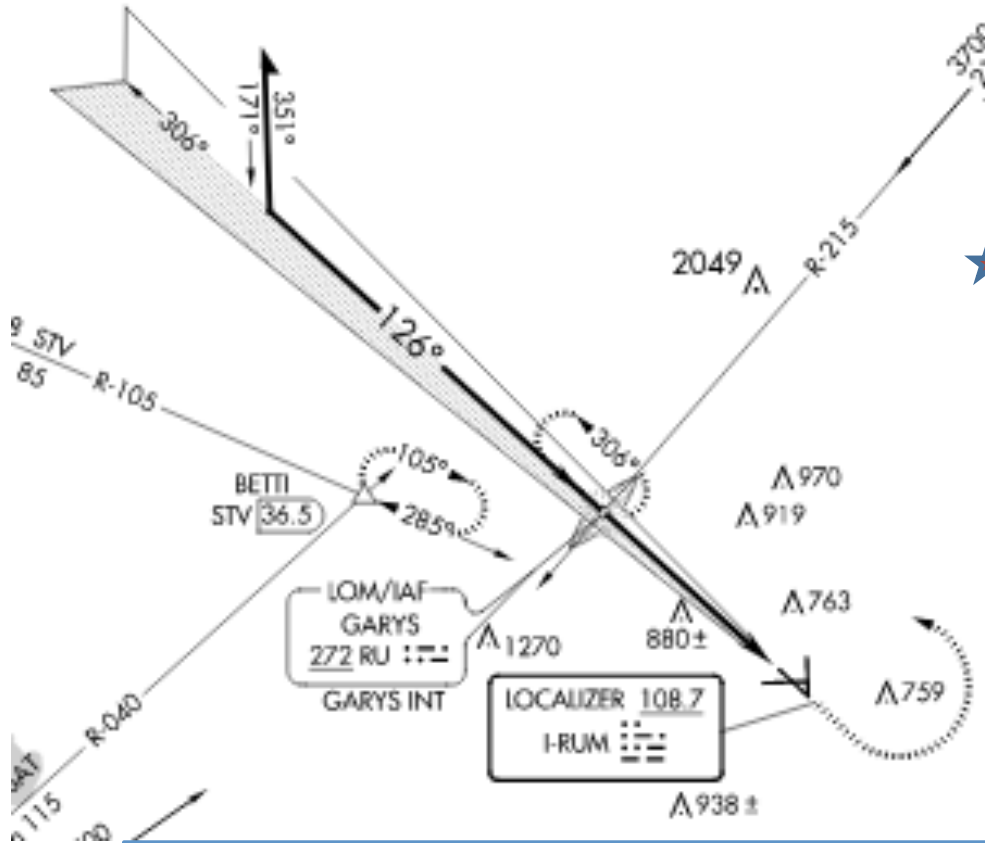
‘Cleared Direct GARYS, ILS 13, Maintain 3,000’ Until Established Inbound, Report PT Inbound’

You are here – how many ways to do a course reversal at GARYS?

What is Risk or Challenge in Conducting Approach From a Hold at GARYS? Hint – Look at Profile View

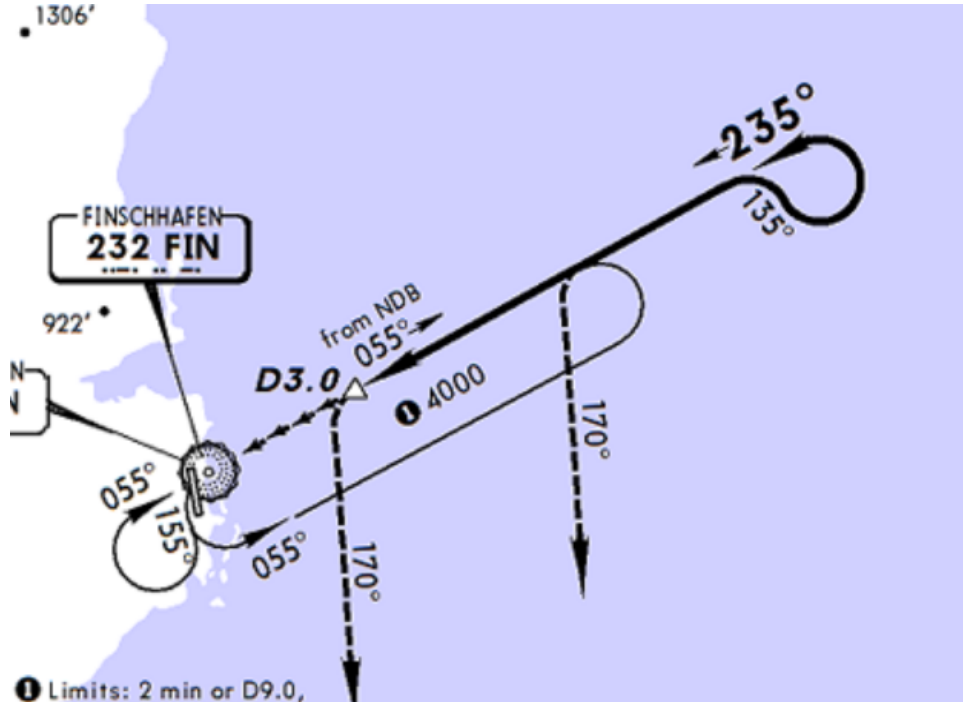
Hold-In-Lieu-of-PT (HILOPT)

‘Falling Out of Favor in ICAO Countries – Still in Instrument Flying Handbook’

‘I Like it Only if There is No Crosswind Component’

270°
090° Holding
in lieu of Procedure Turn

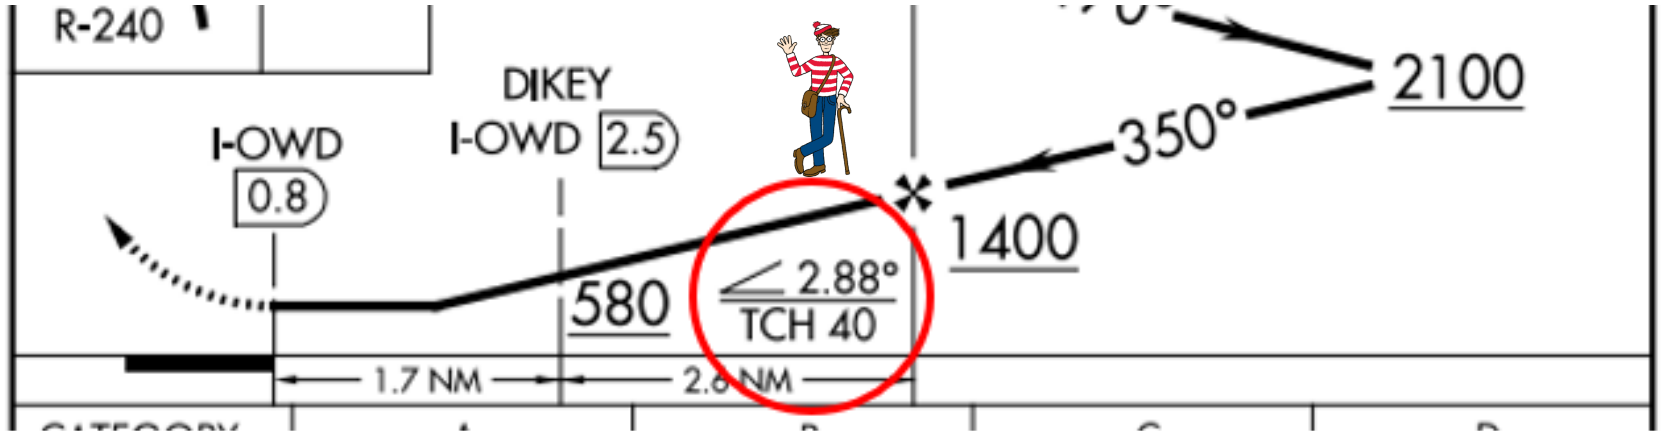
You May See This (Another Waldo) on Some Non-Precision Approaches

What is it?

It is the Vertical Descent Angle. FAA policy is to publish VDAs on all non-precision approaches. Published along with VDA is the Threshold Crossing Height (TCH) that was used to compute the angle. The VDA will end at the runways touchdown zone. The descent angle may be computed from either the final approach fix (FAF), or a stepdown fix, to the runway threshold at the published TCH. A stepdown fix is only used as the start point when an angle computed from the FAF would place the aircraft below the stepdown fix altitude.

The descent angle and TCH information are charted on the profile view of the instrument approach chart following the fix the angle was based on. The optimum descent angle is 3.00 degrees; and whenever possible the approach will be designed using this angle.

The VDA provides the pilot with information not previously available on non-precision approaches. It provides a means for the pilot to establish a stabilized descent from the FAF or stepdown fix to the MDA.
